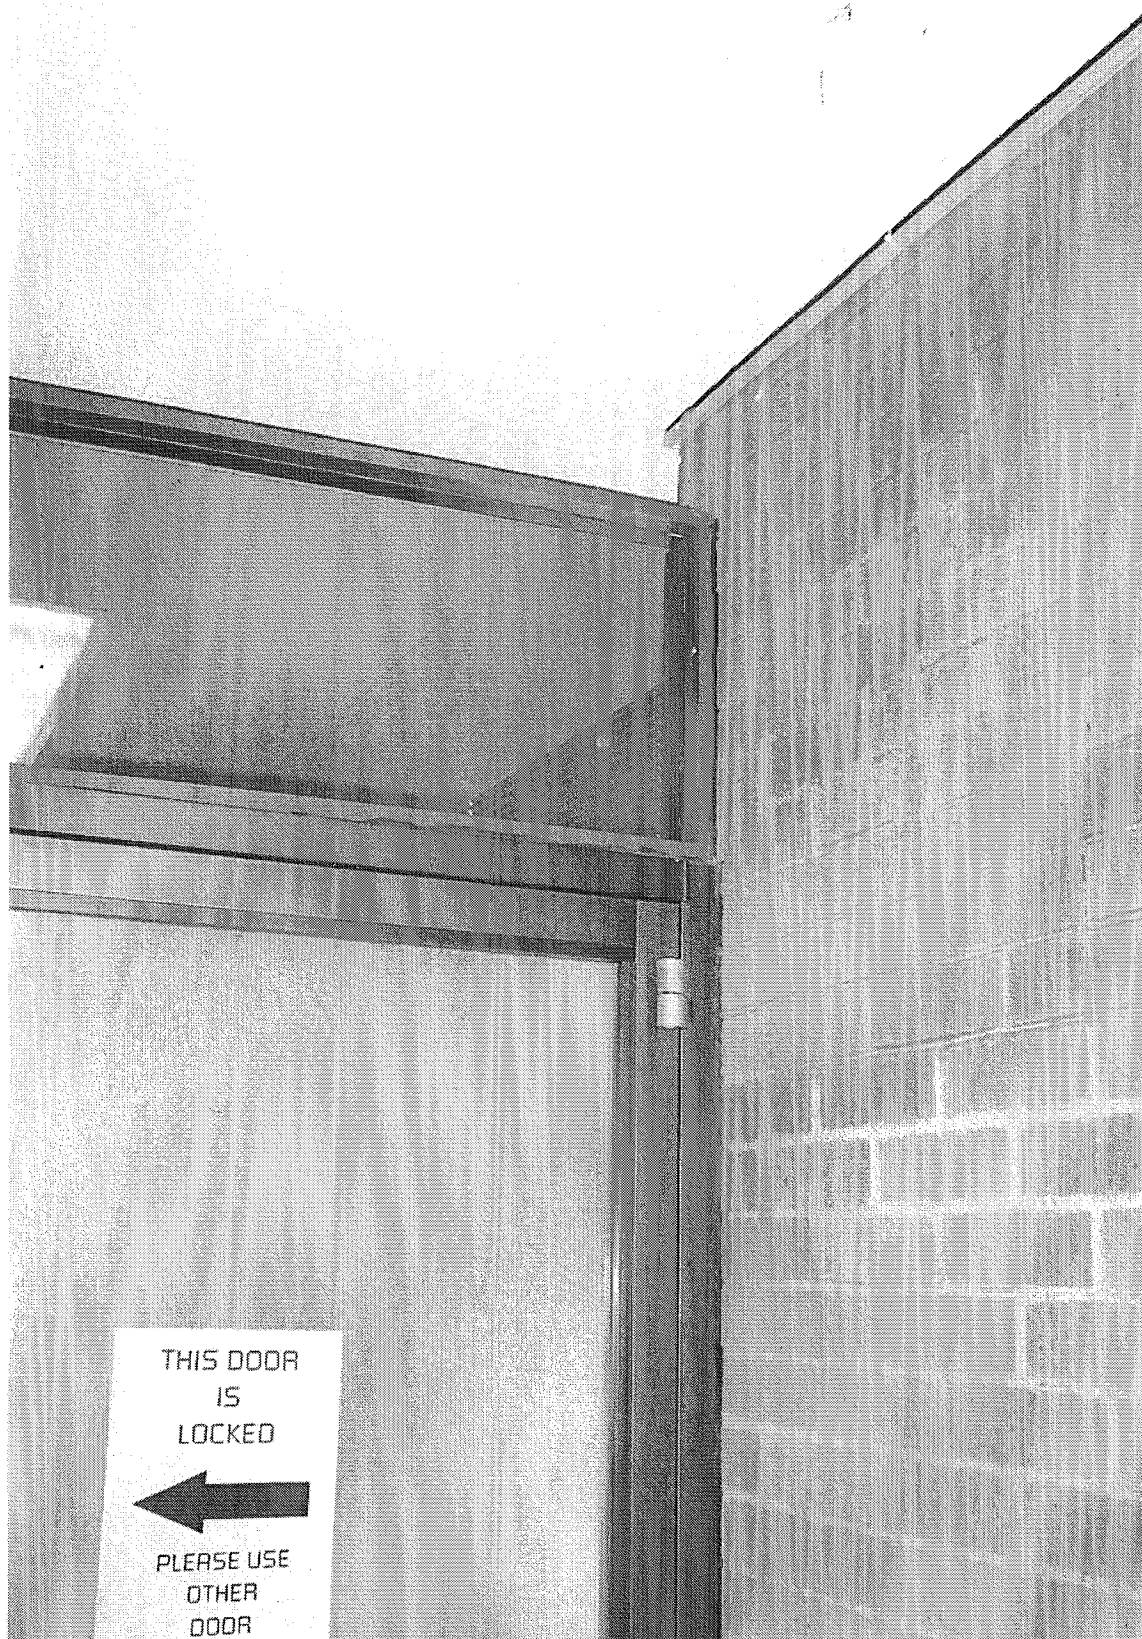
105. 1st floor Sw hallway adj to staff dev - Location of dust sample #2 - top of interior window ledge above door

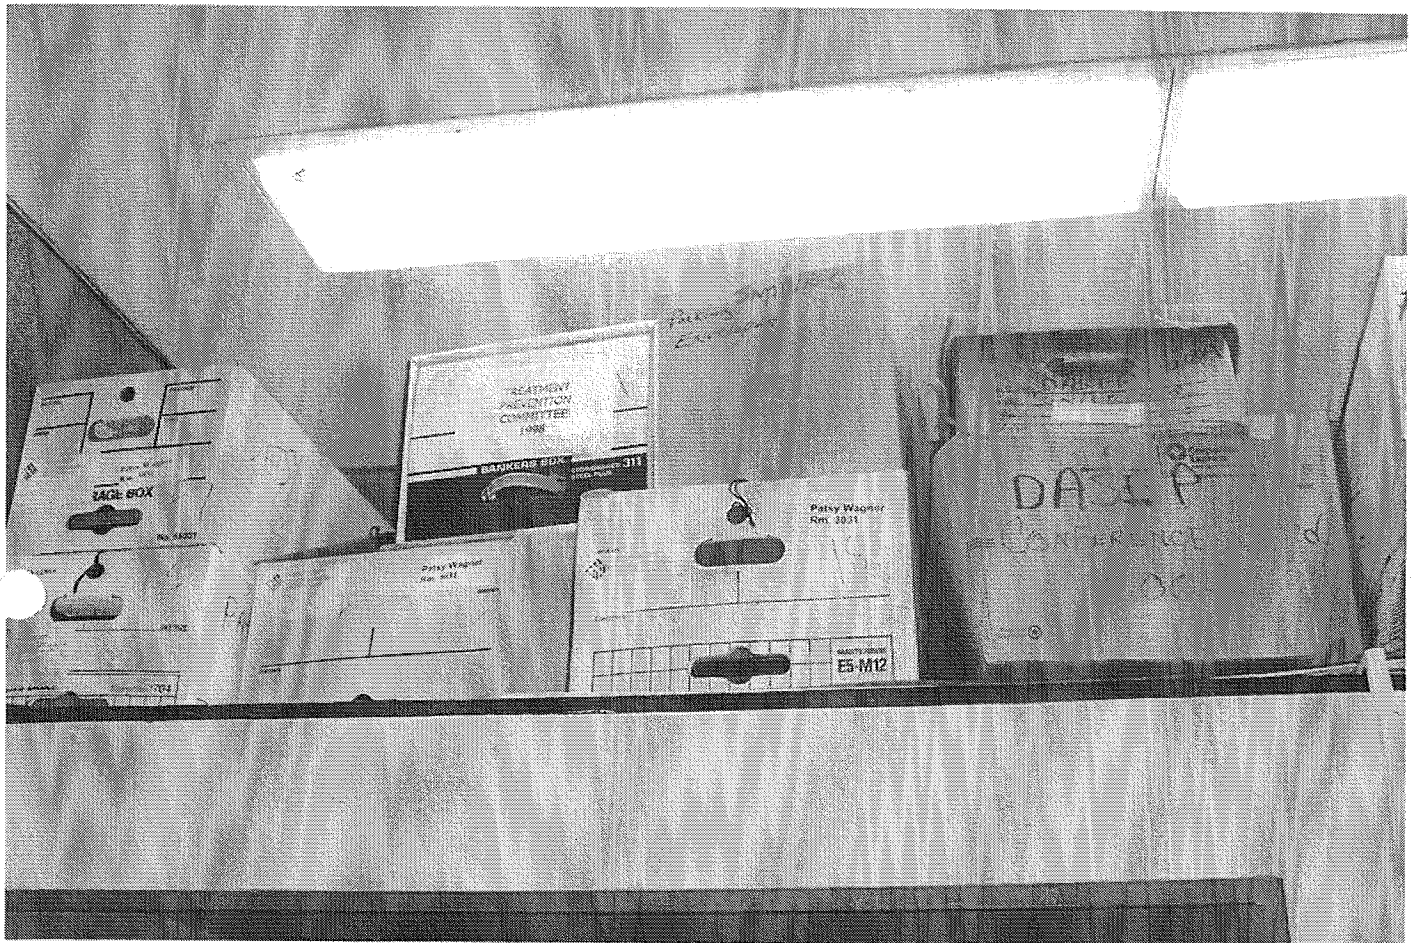
106. 3rd floor Alcohol & Drug Abuse Office - Delaminated acoustical plaster dust and debris on top of shelf

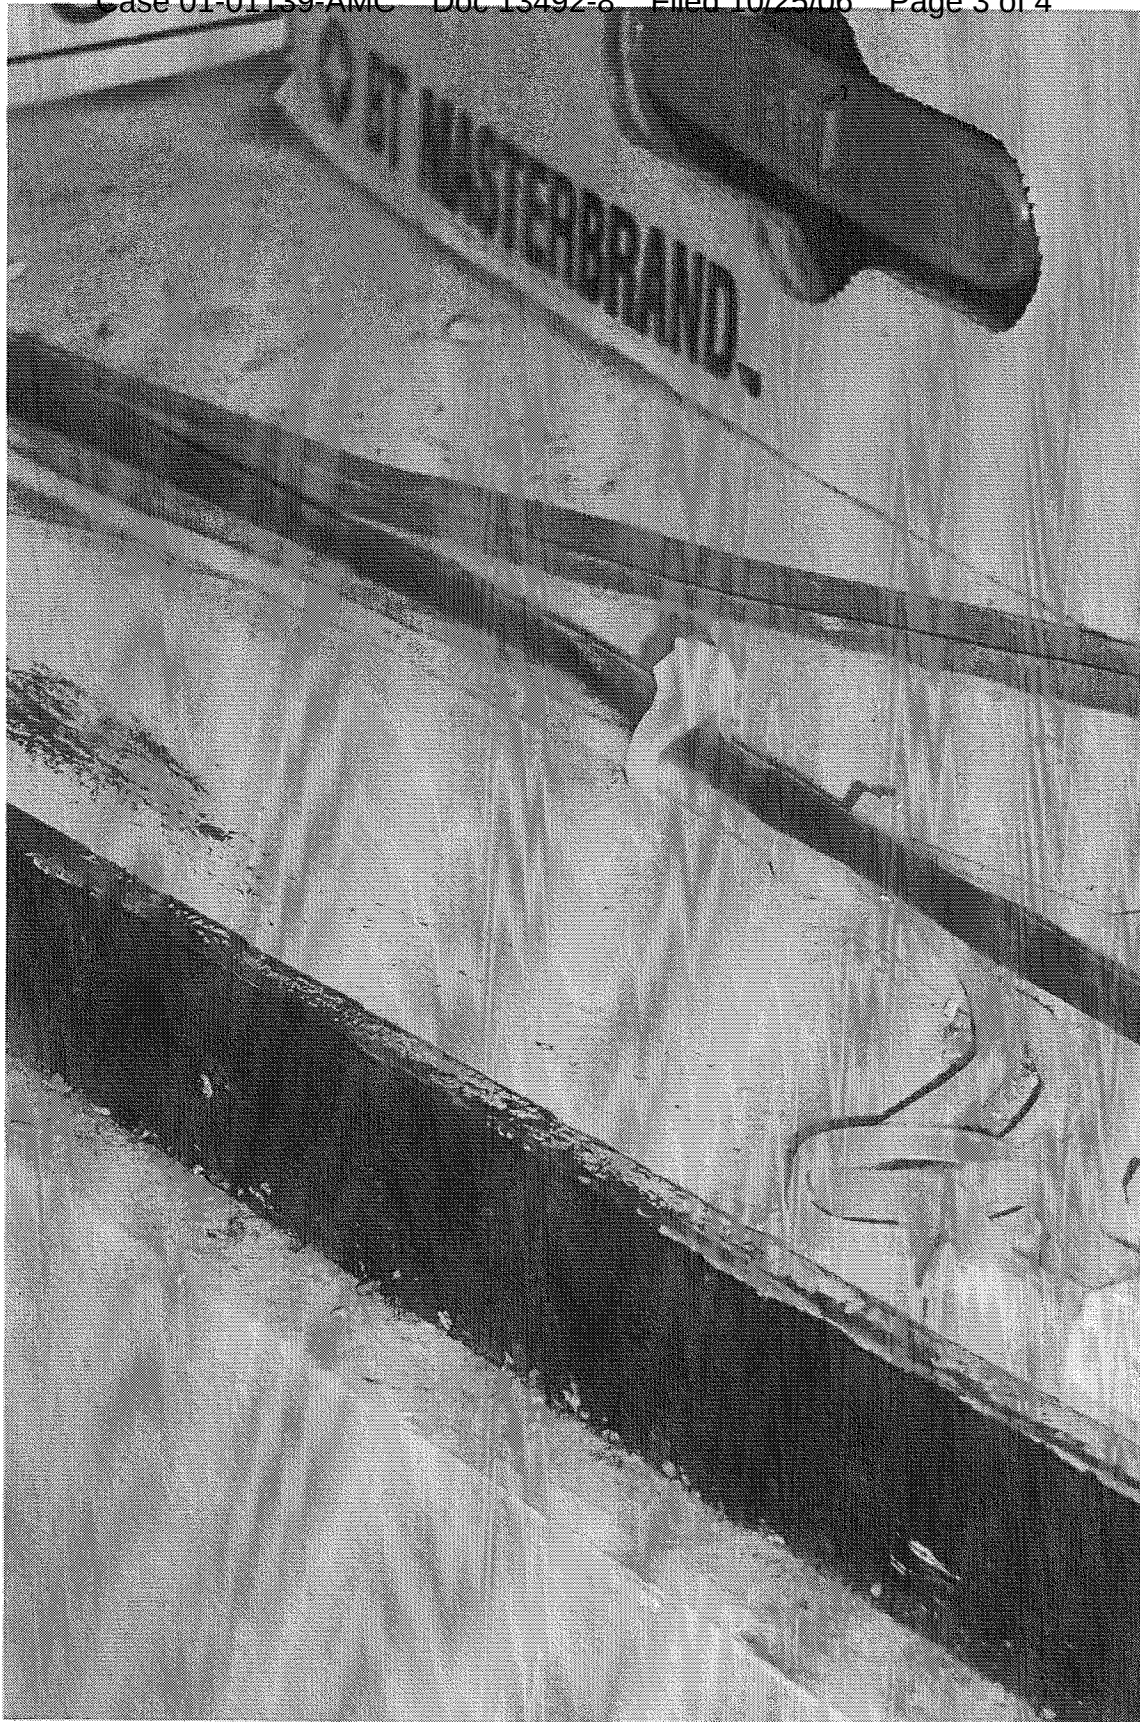
107. 3rd floor Alcohol & Drug Abuse Office - Location of dust sample #3 -Top of storage shelf next to boxes

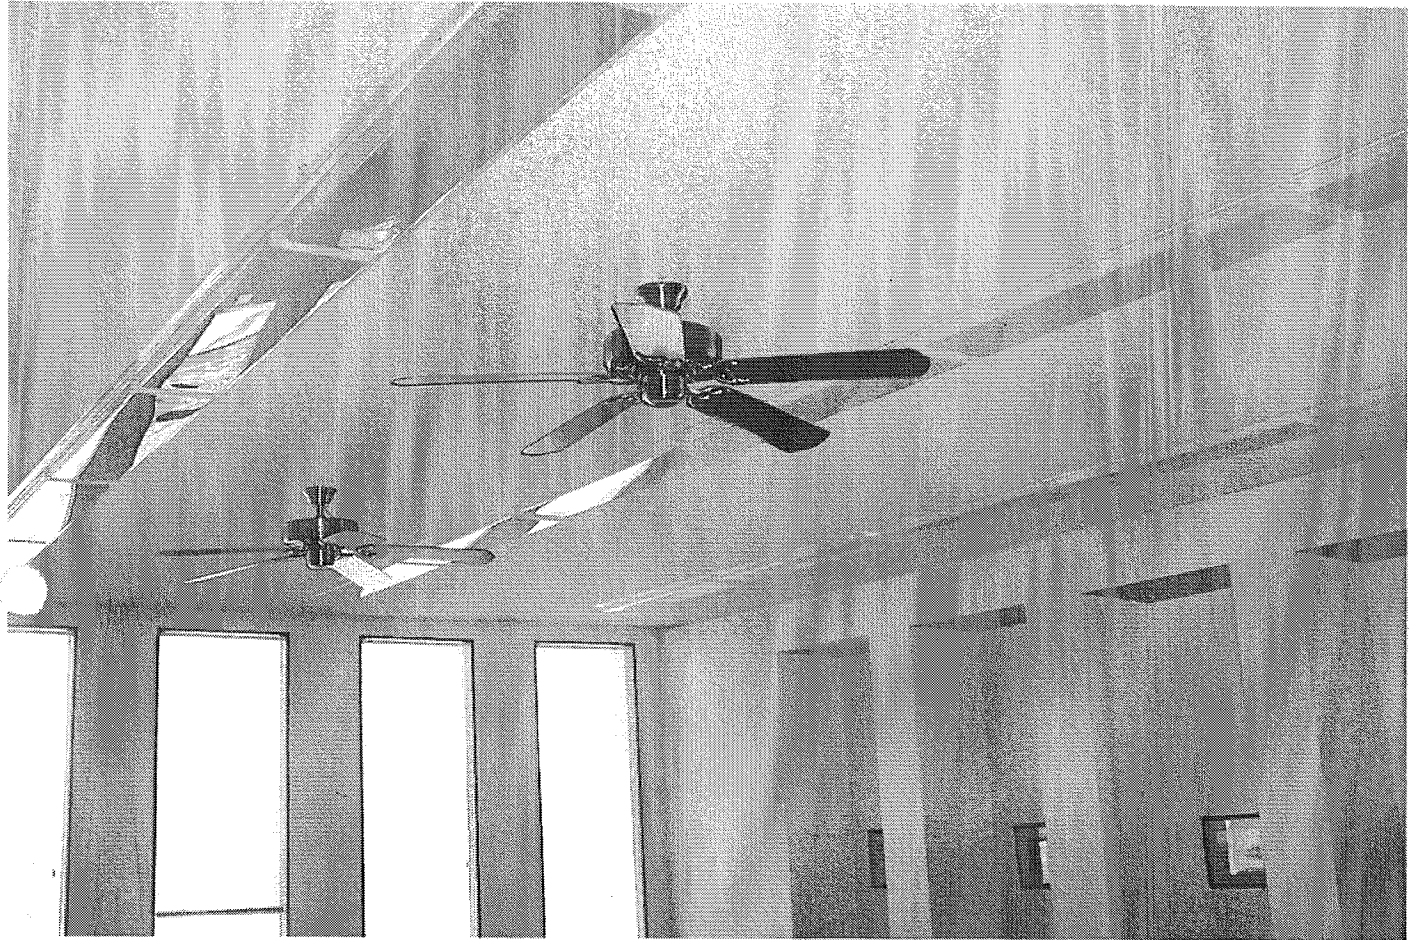
108. 3rd floor NE meeting room - Damaged acoustical plaster above conference table
